**Flood Control Project Maintenance
Levee Inspections****2014 Channel Summary Report****Overall Unit and Item Ratings****DWR Sutter Maintenance Yard**

Flood Control Project Maintenance**Unit Cover Sheet****2014 Channel Inspection Results****DWR Sutter Maintenance Yard**

Channel
Big Chico Creek

Levee Inspection Report By Mile - Channel 2014

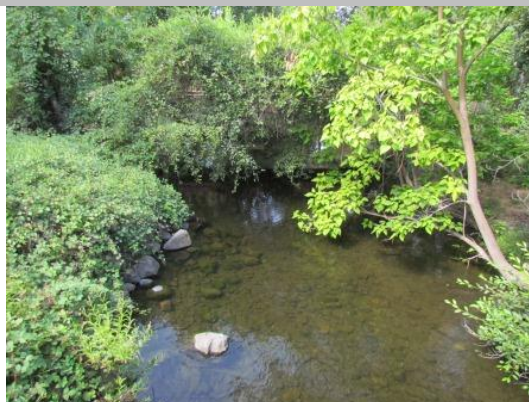
Photo 1 of 1 : CH_2014_NA0060_5_16_20140721_00016.jpg

Rating **	A	Issue No.	16	GPS Lat/Long
Issue Type +	Ma	Location *		39.758260 °
Category	Rivers, Channels & Designated Flood			-121.795380 °
Item	Vegetation & Obstructions			
DWR ID	DWR_NA0060_5_c_2012_16			
Action/Comments				
Inspector Comments: Minimal, scattered obstructions and vegetation. The flow is not impeded.

This photo is looking downstream on Manzanita Ave.

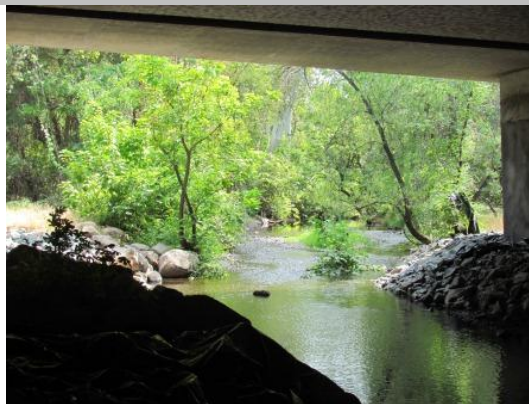
Photo 1 of 1 : CH_2014_NA0060_5_21_20140721_00017.jpg

Inspector Comments: Minimal scattered obstructions or vegetation. The flow is not impeded.

View upstream of Big Chico Creek at Highway 99.

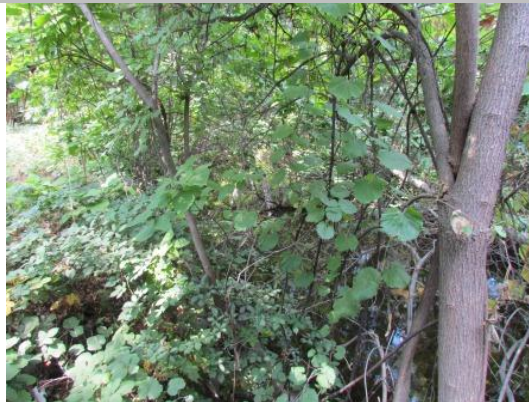
Photo 1 of 1 : CH_2014_NA0060_5_26_20140721_00018.jpg

Check Point / View				
Hwy 99 Bridge / Down				
Rating **	A	Issue No.	26	GPS Lat/Long
Issue Type +	Ma	Location *		39.738490 °
Category	Rivers, Channels & Designated Flood			-121.822810 °
Item	Vegetation & Obstructions			
DWR ID	DWR_NA0060_5_c_2012_26			
Action/Comments				
Inspector Comments: Minimal scattered obstructions or vegetation. The flow is not impeded.

View downstream of Big Chico Creek at Highway 99.

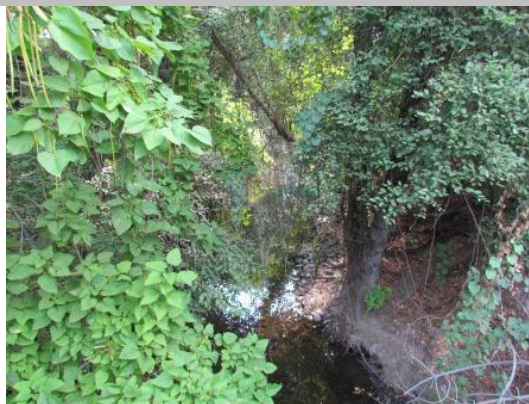
Photo 1 of 1 : CH_2014_NA0060_5_31_20140721_00019.jpg

Rating **	A	Issue No.	31	GPS Lat/Long
Issue Type +	Ma	Location *		39.731810 °
Category	Rivers, Channels & Designated Flood			-121.841870 °
Item	Vegetation & Obstructions			
DWR ID	DWR_NA0060_5_c_2012_31			
Action/Comments				
Inspector Comments: Scattered obstructions and vegetation. The flow is not impeded.

This photo is looking upstream from Esplanade Avenue.

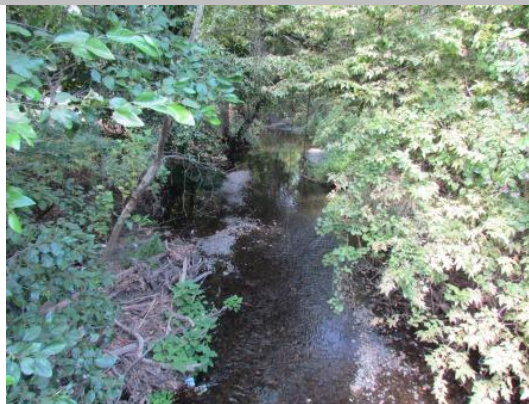
Photo 1 of 1 : CH_2014_NA0060_5_36_20140721_00020.jpg

Inspector Comments: Scattered obstructions and vegetation. The flow is not impeded.

This view is looking downstream from Esplanade Avenue.

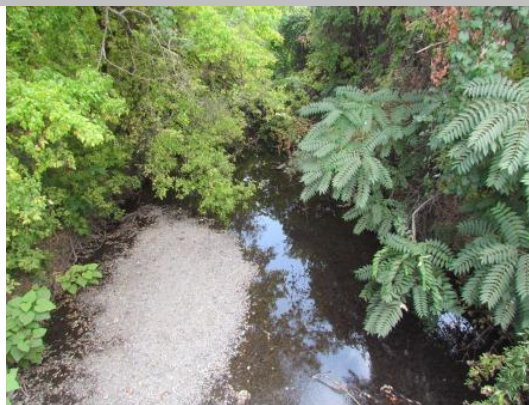
Photo 1 of 1 : CH_2014_NA0060_5_41_20140721_00021.jpg

Check Point / View				
Hwy 32 / Up				
Rating **	A	Issue No.	41	GPS Lat/Long
Issue Type +	Ma	Location *		39.725860 °
Category	Rivers, Channels & Designated Flood			-121.851360 °
Item	Vegetation & Obstructions			
DWR ID	DWR_NA0060_5_c_2012_41			
Action/Comments				
Inspector Comments: Scattered obstructions and vegetation. The flow is not impeded.

This photo is looking upstream from Highway 32 bridge.

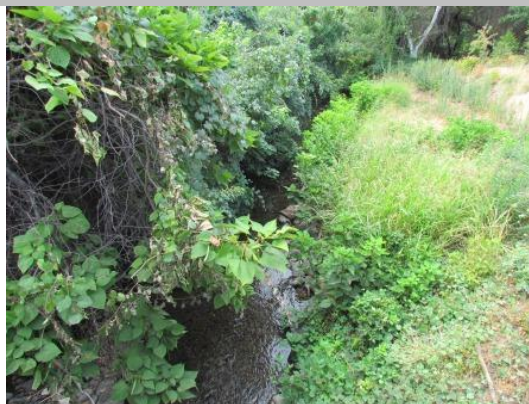
Photo 1 of 1 : CH_2014_NA0060_5_46_20140721_00022.jpg

Inspector Comments: Moderate vegetation on north bank. The flow is not impeded.

This photo is looking downstream from Highway 32.

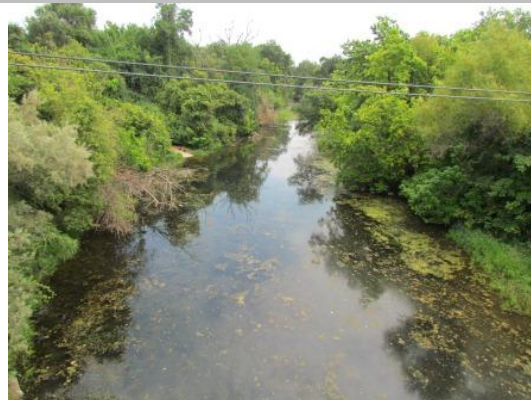
Photo 1 of 1 : CH_2014_NA0060_5_51_20140721_00023.jpg

Check Point / View				
Mud Creek at River Rd / Up				
Rating **	A	Issue No.	51	GPS Lat/Long
Issue Type +	Ma	Location *		39.704580 °
Category	Rivers, Channels & Designated Flood			-121.939320 °
Item	Vegetation & Obstructions			
DWR ID	DWR_NA0060_5_c_2012_51			
Action/Comments				
Inspector Comments: Scattered obstructions and vegetation. The flow is not impeded.

This photo is looking upstream from River Road at Mud Creek, near the confluence with the Sacramento River.

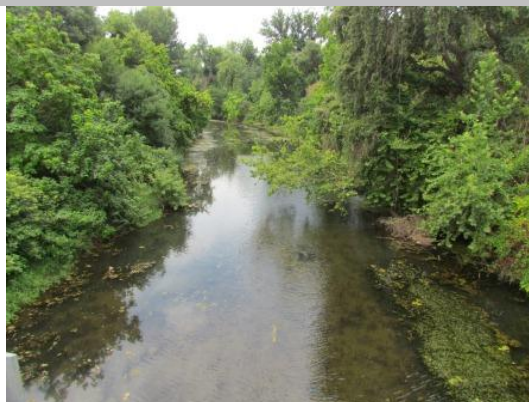
Photo 1 of 1 : CH_2014_NA0060_5_56_20140721_00024.jpg

Check Point / View			
Mud Creek at River Rd / Down			
Rating **	A	Issue No.	56
Issue Type +	Ma	Location *	39.704580 °
Category	Rivers, Channels & Designated Flood		-121.939320 °
Item	Vegetation & Obstructions		
DWR ID	DWR_NA0060_5_c_2012_56		
Action/Comments			
Inspector Comments: Scattered obstructions and vegetation. The flow is not impeded.

This photo is looking downstream from the River Road bridge, near the confluence of the Sacramento River.

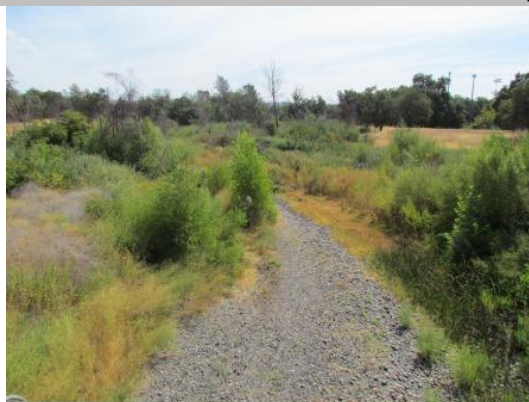
Photo 1 of 1 : CH_2014_NA0060_6_1_20140721_00025.jpg

Inspector Comments: Minimal, scattered obstructions and small trees. The flow is not impeded.

This is a view of the upstream side of the Lindo Control Structure.

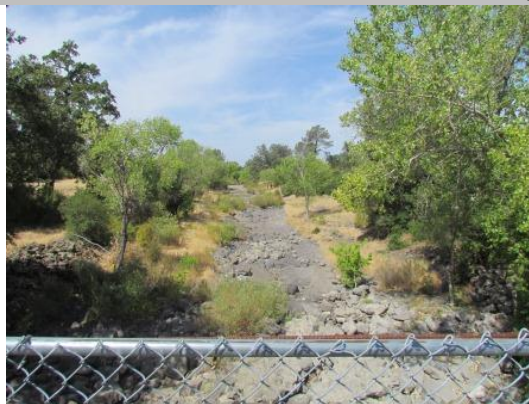
Photo 1 of 1 : CH_2014_NA0060_6_6_20140721_00023.jpg

Inspector Comments: Minimal, scattered obstructions or vegetation. The flow is not impeded.

This view is of the downstream side of the control structure.

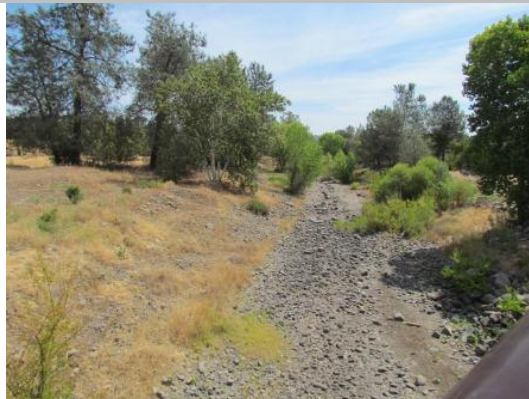
Photo 1 of 1 : CH_2014_NA0060_6_11_20140721_00026.jpg

Check Point / View				
Manzanita Ave / Up				
Rating **	A	Issue No.	11	GPS Lat/Long
Issue Type +	Ma	Location *		39.760510 °
Category	Rivers, Channels & Designated Flood			121.802070 °
Item	Vegetation & Obstructions			
DWR ID	DWR_NA0060_6_c_2012_11			
Action/Comments				
Inspector Comments: Minimal, scattered obstructions or vegetation. The flow is not impeded.

This view is looking upstream from Manzanita Avenue.

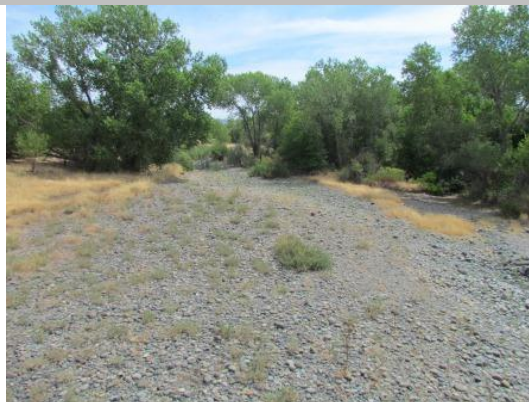
Photo 1 of 1 : CH_2014_NA0060_6_21_20140721_00028.jpg

Check Point / View				
Bike Path Bridge at Madrone Ave / Up				
Rating **	A	Issue No.	21	GPS Lat/Long
Issue Type +	Ma	Location *		39.755400 °
Category	Rivers, Channels & Designated Flood			121.814580 °
Item	Vegetation & Obstructions			
DWR ID	DWR_NA0060_6_c_2012_21			
Action/Comments				
Inspector Comments: Minimal, scattered obstructions or vegetation. The flow is not impeded.

This view is looking up stream from the bike path bridge at the extension of Madrone Avenue.

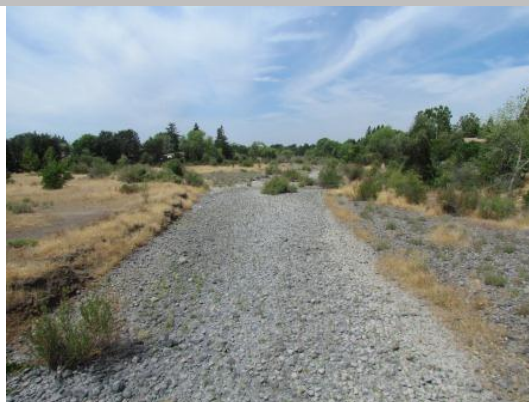
Photo 1 of 1 : CH_2014_NA0060_6_26_20140721_00029.jpg

Inspector Comments: Minimal, scattered obstructions or vegetation. The flow is not impeded.

This photo is looking downstream from the bike path at the extension of Madrone Avenue.

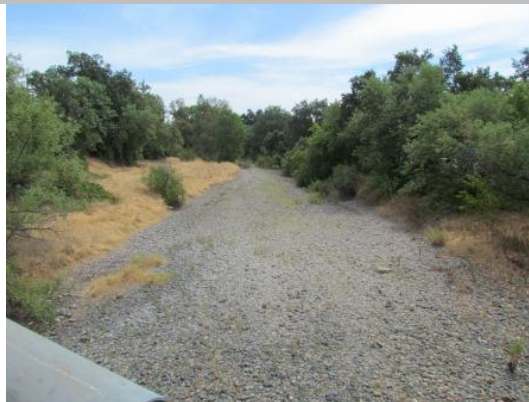
Photo 1 of 1 : CH_2014_NA0060_6_31_20140721_00030.jpg

Rating **	A	Issue No.	31	GPS Lat/Long
Issue Type +	Ma	Location *		39.752730 °
Category	Rivers, Channels & Designated Flood			-121.824560 °
Item	Vegetation & Obstructions			
DWR ID	DWR_NA0060_6_c_2012_31			
Action/Comments				
Inspector Comments: Minimal, scattered obstructions or vegetation. The flow is not impeded.

This view is looking upstream from the bridge at Mariposa Avenue.

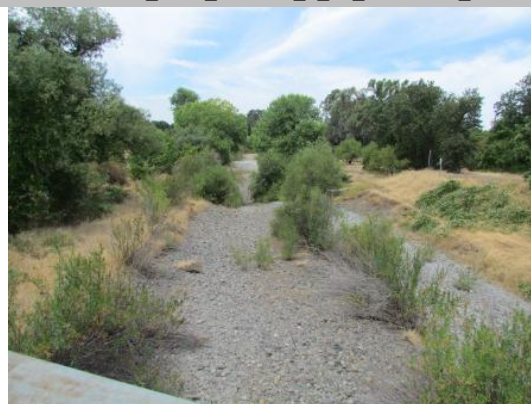
Photo 1 of 1 : CH_2014_NA0060_6_36_20140721_00031.jpg

Inspector Comments: Minimal, scattered obstructions or vegetation. The flow is not impeded.

This photo is looking downstream from the Mariposa Avenue bridge.

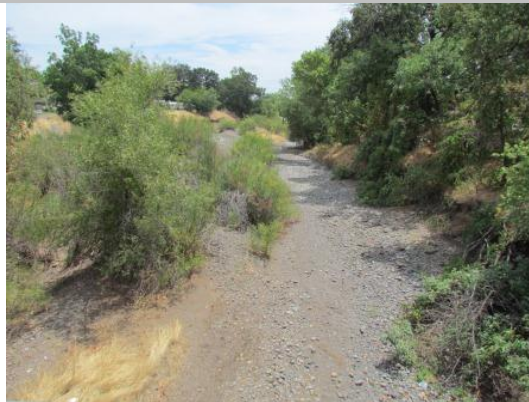
Photo 1 of 1 : CH_2014_NA0060_6_41_20140721_00032.jpg

Check Point / View				
5th Ave / Up				
Rating **	A	Issue No.	41	GPS Lat/Long
Issue Type +	Ma	Location *		39.752332 °
Category	Rivers, Channels & Designated Flood			-121.829199 °
Item	Vegetation & Obstructions			
DWR ID	DWR_NA0060_6_c_2012_41			
Action/Comments				
Inspector Comments: Minimal, scattered obstructions or vegetation. The flow is not impeded.

This photo is looking upstream from 5th Ave.

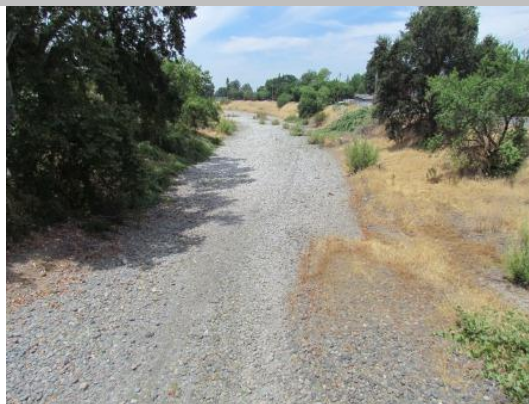
Photo 1 of 1 : CH_2014_NA0060_6_46_20140721_00033.jpg

Rating **	A	Issue No.	46	GPS Lat/Long
Issue Type +	Ma	Location *		39.752332 °
Category	Rivers, Channels & Designated Flood			-121.829199 °
Item	Vegetation & Obstructions			
DWR ID	DWR_NA0060_6_c_2012_46			
Action/Comments				
Inspector Comments: Minimal, scattered obstructions or vegetation. The flow is not impeded.

This photo is looking downstream from 5th Ave.

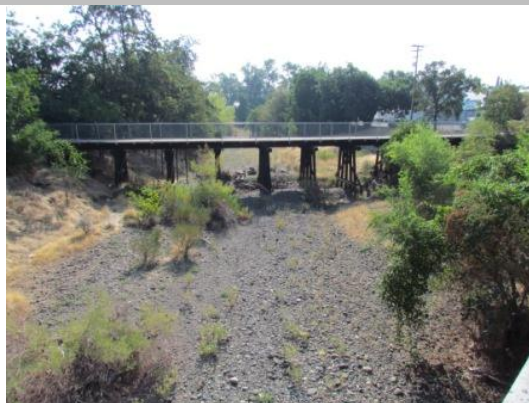
Photo 2 of 2 : CH_2014_NA0060_6_51_20140630_00014.jpg

Concrete cracking on south side wing wall upstream of Esplanade Ave.

This view is looking upstream from Esplanade Avenue bridge.

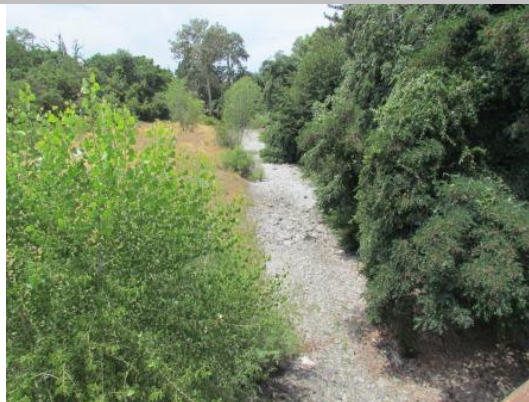
Photo 1 of 2 : CH_2014_NA0060_6_56_20140721_00034.jpg

Rating **	A	Issue No.	56 (cont)	GPS Lat/Long
Issue Type +	Ma	Location *		39.749380 °
Category	Rivers, Channels & Designated Flood			-121.854400 °
Item	Vegetation & Obstructions			
DWR ID	DWR_NA0060_6_c _ 2012_56

This photo is looking downstream from Esplanade Avenue bridge.

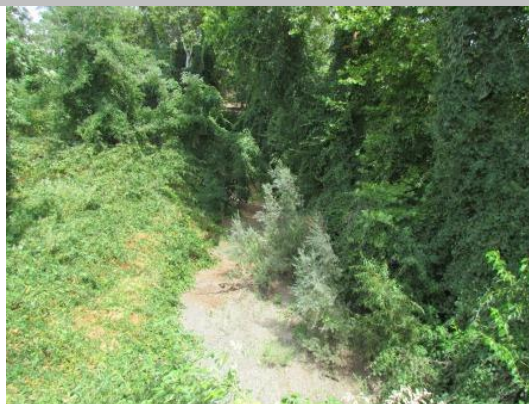
Photo 1 of 1 : CH_2014_NA0060_6_61_20140721_00035.jpg

Rating **	A	Issue No.	61	GPS Lat/Long
Issue Type +	Ma	Location *		39.741190 °
Category	Rivers, Channels & Designated Flood			-121.881380 °
Item	Vegetation & Obstructions			
DWR ID	DWR_NA0060_6_c _ 2012_61			
Action/Comments				
Inspector Comments: Vegetation exists but does not impede the flow.

This view is looking upstream from the Highway 32, Nord Avenue bridge.

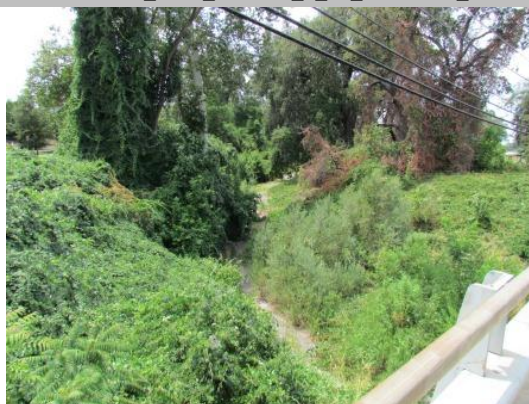
Photo 1 of 1 : CH_2014_NA0060_6_66_20140721_00036.jpg

Check Point / View				
Hwy 32 / Down				
Rating **	A	Issue No.	66	GPS Lat/Long
Issue Type +	Ma	Location *		39.741190 °
Category	Rivers, Channels & Designated Flood			-121.881380 °
Item	Vegetation & Obstructions			
DWR ID	DWR_NA0060_6_c_2012_66			
Action/Comments				
Inspector Comments: Vegetation exists but does not impede the flow.

This photo is looking downstream from Highway 32, Nord Avenue bridge.

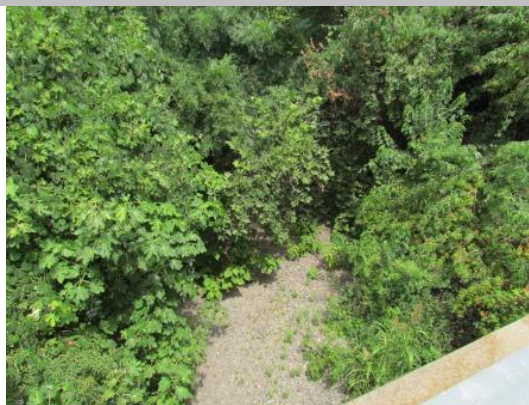
Photo 1 of 1 : CH_2014_NA0060_6_71_20140721_00037.jpg

Check Point / View				
Oak Ave. / Up				
Rating **	A	Issue No.	71	GPS Lat/Long
Issue Type +	Ma	Location *		39.735560 °
Category	Rivers, Channels & Designated Flood			-121.890970 °
Item	Vegetation & Obstructions			
DWR ID	DWR_NA0060_6_c_2012_71			
Action/Comments				
Inspector Comments: Scattered obstructions and vegetation.

This photo is looking upstream from Oak Ave. bridge.

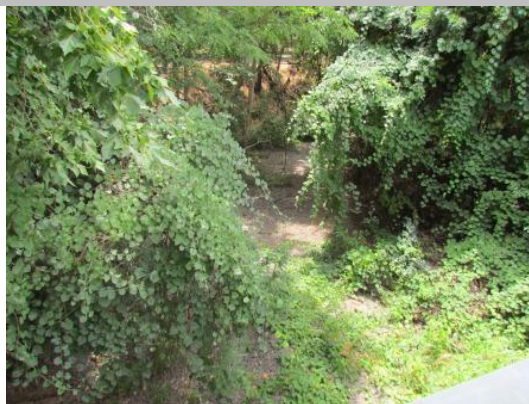
Photo 1 of 1 : CH_2014_NA0060_6_76_20140721_00038.jpg

Rating **	A	Issue No.	76	GPS Lat/Long
Issue Type +	Ma	Location *		39.735560 °
Category	Rivers, Channels & Designated Flood			-121.890970 °
Item	Vegetation & Obstructions			
DWR ID	DWR_NA0060_6_c_2012_76			
Action/Comments				
Inspector Comments: scattered obstructions and vegetation.

This photo is looking downstream from Oak Ave. bridge.

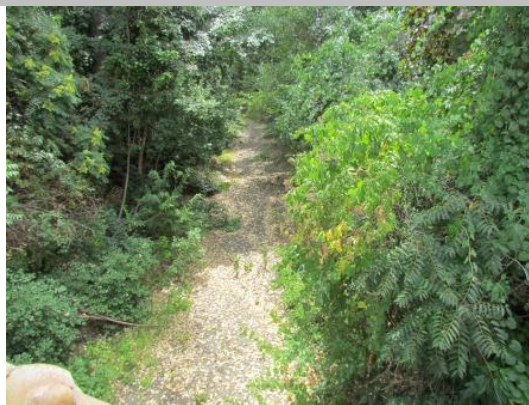
Photo 1 of 1 : CH_2014_NA0060_6_86_20140721_00040.jpg

Check Point / View				
Grape Way / Down				
Rating **	A	Issue No.	86	GPS Lat/Long
Issue Type +	Ma	Location *		39.722700 °
Category	Rivers, Channels & Designated Flood			-121.912520 °
Item	Vegetation & Obstructions			
DWR ID	DWR_NA0060_6_c_2012_86			
Action/Comments				
Inspector Comments: Scattered obstructions and vegetation.

This view is looking downstream at the channel at the Grape Way bridge.

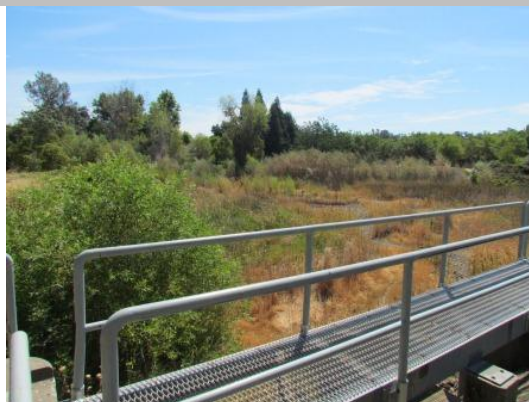
Photo 1 of 1 : CH_2014_NA0060_12_1_20140721_00017.jpg

Rating **	A	Issue No.	1	GPS Lat/Long
Issue Type +	Ma	Location *		39.733890 °
Category	Rivers, Channels & Designated Flood			-121.771940 °
Item	Vegetation & Obstructions			
DWR ID	DWR_NA0060_12_c_2012_1			
Action/Comments				
Inspector Comments: Minimal, scattered obstructions and vegetation. The flow is not impeded.

This is the upstream side at the Little Chico Control Structure.

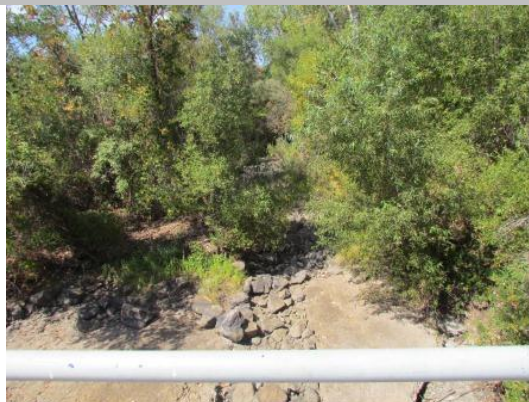
Photo 1 of 1 : CH_2014_NA0060_12_6_20140721_00018.jpg

Inspector Comments: Scattered obstructions and vegetation. The flow is not impeded. Willow trees should be removed in the future.

This photo is looking downstream from the control structure.

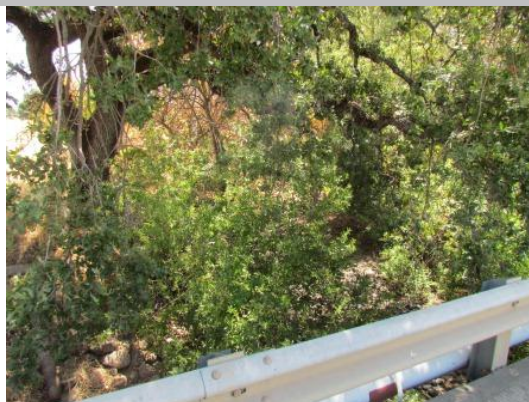
Photo 1 of 1 : CH_2014_NA0060_12_11_20140721_00019.jpg

Inspector Comments: The vegetation obstructed the view of the channel. Flow may be impeded in high water.

This photo is looking upstream from Bruce Road bridge.

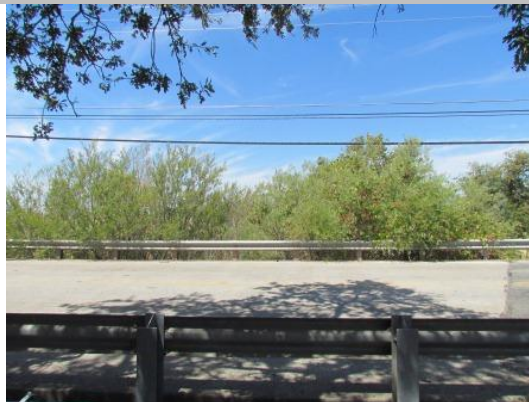
Photo 1 of 1 : CH_2014_NA0060_12_16_20140721_00020.jpg

Inspector Comments: The vegetation obstructed the view of the channel. Flow may be impeded in high water.

This photo is looking downstream from Bruce Road bridge.

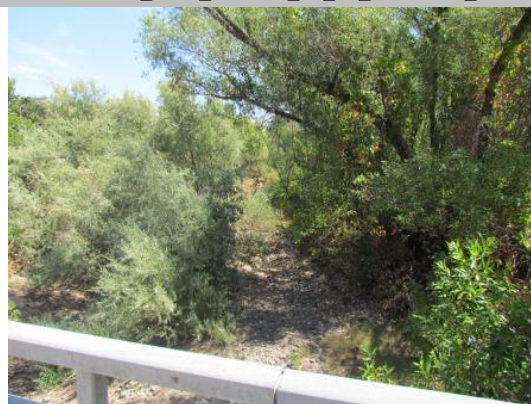
Photo 1 of 1 : CH_2014_NA0060_12_21_20140721_00021.jpg

Inspector Comments: Minimal, scattered obstructions and vegetation. The flow does not appear impeded.

This photo is looking upstream from Forest Avenue bridge.

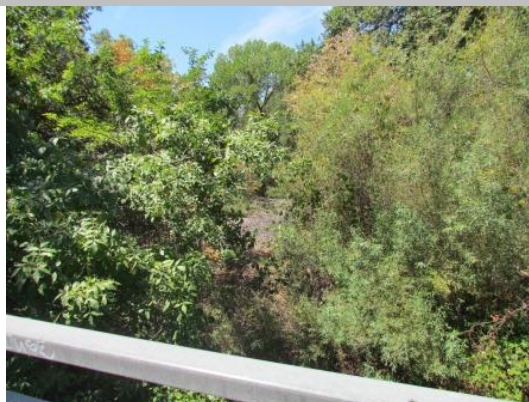
Photo 1 of 1 : CH_2014_NA0060_12_26_20140721_00022.jpg

Inspector Comments: Moderate vegetation observed. Flow may be obstructed in high water.

This photo is looking downstream from Forest Avenue bridge.

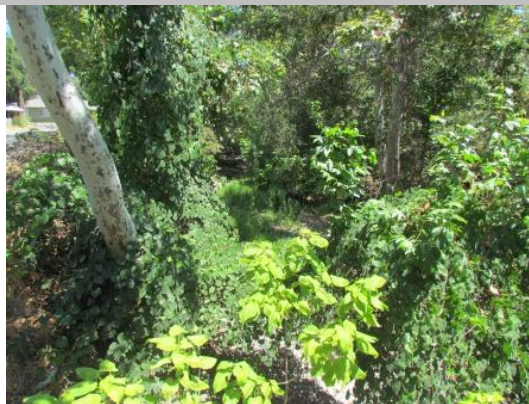
Photo 1 of 1 : CH_2014_NA0060_12_41_20140721_00025.jpg

Inspector Comments: There is vegetation in the channel and overhanging the channel, the flow does not appear impeded.

This photo is looking upstream from Boucher Street bridge.

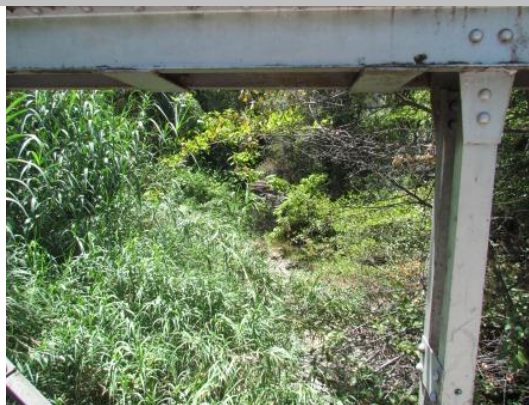
Photo 1 of 1 : CH_2014_NA0060_12_46_20140721_00026.jpg

Inspector Comments: There is vegetation in the channel, overhanging the channel, and arndo the flow does not appear impeded.

This photo is looking downstream from Boucher Street bridge.

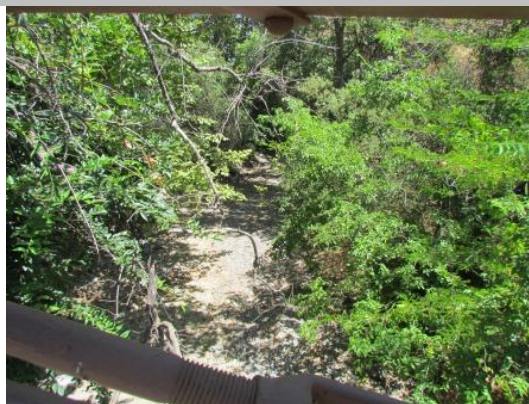
Photo 1 of 1 : CH_2014_NA0060_12_51_20140721_00027.jpg

Rating **	A	Issue No.	51	GPS Lat/Long
Issue Type +	Ma	Location *		39.726800 °
Category	Rivers, Channels & Designated Flood			-121.829870 °
Item	Vegetation & Obstructions			
DWR ID	DWR_NA0060_12_c_2012_51			
Action/Comments				
Inspector Comments: There is vegetation in the channel, it does not appear to impeded the flow.

This photo is looking upstream from Olive Street bridge.

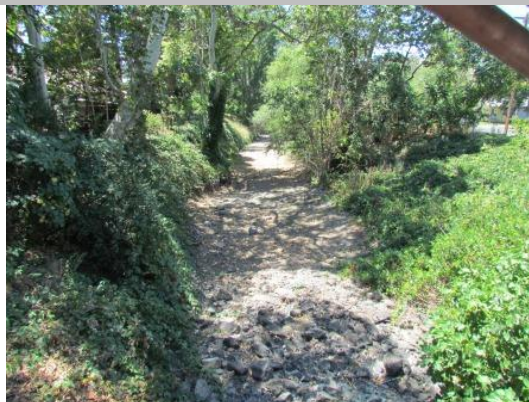
Photo 1 of 1 : CH_2014_NA0060_12_56_20140721_00028.jpg

Check Point / View				
Olive St / Down				
Rating **	A	Issue No.	56	GPS Lat/Long
Issue Type +	Ma	Location *		39.726800 °
Category	Rivers, Channels & Designated Flood			-121.829870 °
Item	Vegetation & Obstructions			
DWR ID	DWR_NA0060_12_c_2012_56			
Action/Comments				
Inspector Comments: There is vegetation in the channel, the flow does not appear impeded.

This photo is looking downstream from the Olive Street bridge.

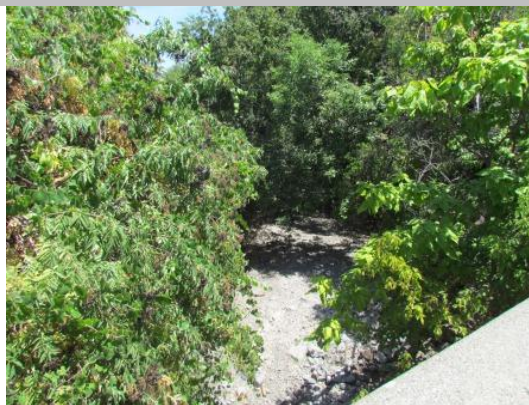
Photo 1 of 1 : CH_2014_NA0060_12_61_20140721_00029.jpg

Check Point / View				
Broadway St / Up				
Rating **	A	Issue No.	61	GPS Lat/Long
Issue Type +	Ma	Location *		39.724840 °
Category	Rivers, Channels & Designated Flood			-121.833520 °
Item	Vegetation & Obstructions			
DWR ID	DWR_NA0060_12_c_2012_61			
Action/Comments				
Inspector Comments: There is vegetation in the channel, the flow does not appear impeded.

This photo is looking upstream from the Broadway St. bridge.

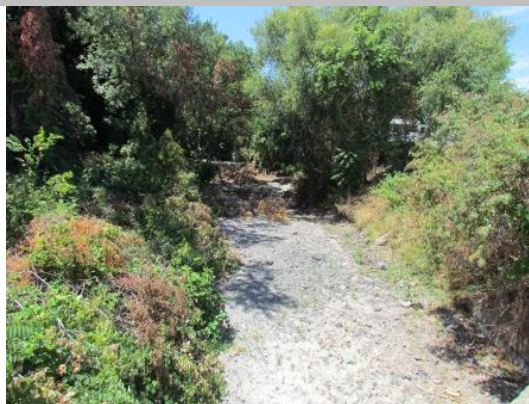
Photo 1 of 1 : CH_2014_NA0060_12_66_20140721_00030.jpg

Inspector Comments: There is vegetation in the channel, the flow does not appear impeded.

This photo is looking downstream from Broadway St. bridge.

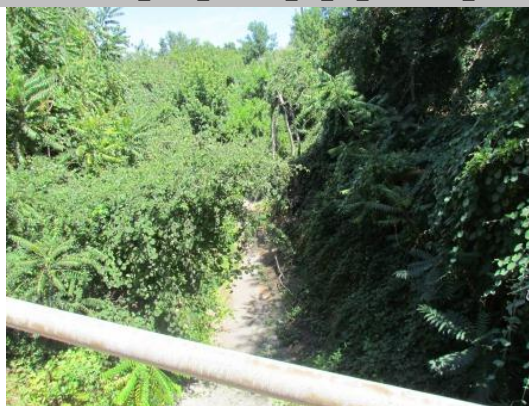
Photo 1 of 1 : CH_2014_NA0060_12_71_20140721_00031.jpg

Inspector Comments: There is vegetation in the channel, the flow does not appear impeded.

This photo is looking upstream from Lone Pine Avenue.

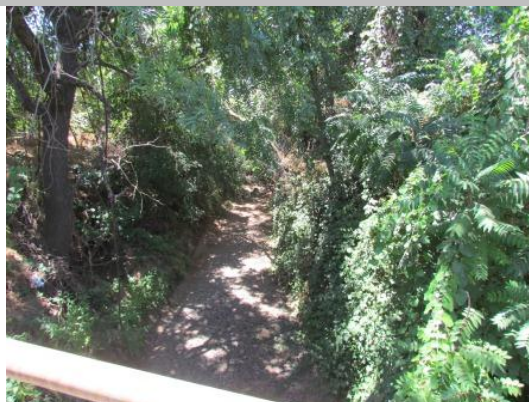
Photo 1 of 1 : CH_2014_NA0060_12_76_20140721_00032.jpg

Inspector Comments: There is vegetation in the channel, the flow does not appear impeded.

This photo is looking down stream from Lone Pine Avenue.
